# GEOPHYSICAL SURVEY

METALLIC UST INVESTIGATION:  
PARCEL 1  
NCDOT PROJECT P-5705B (44475.1.2)

301 N. SMITH ST., CHARLOTTE, NC

SEPTEMBER 14, 2017

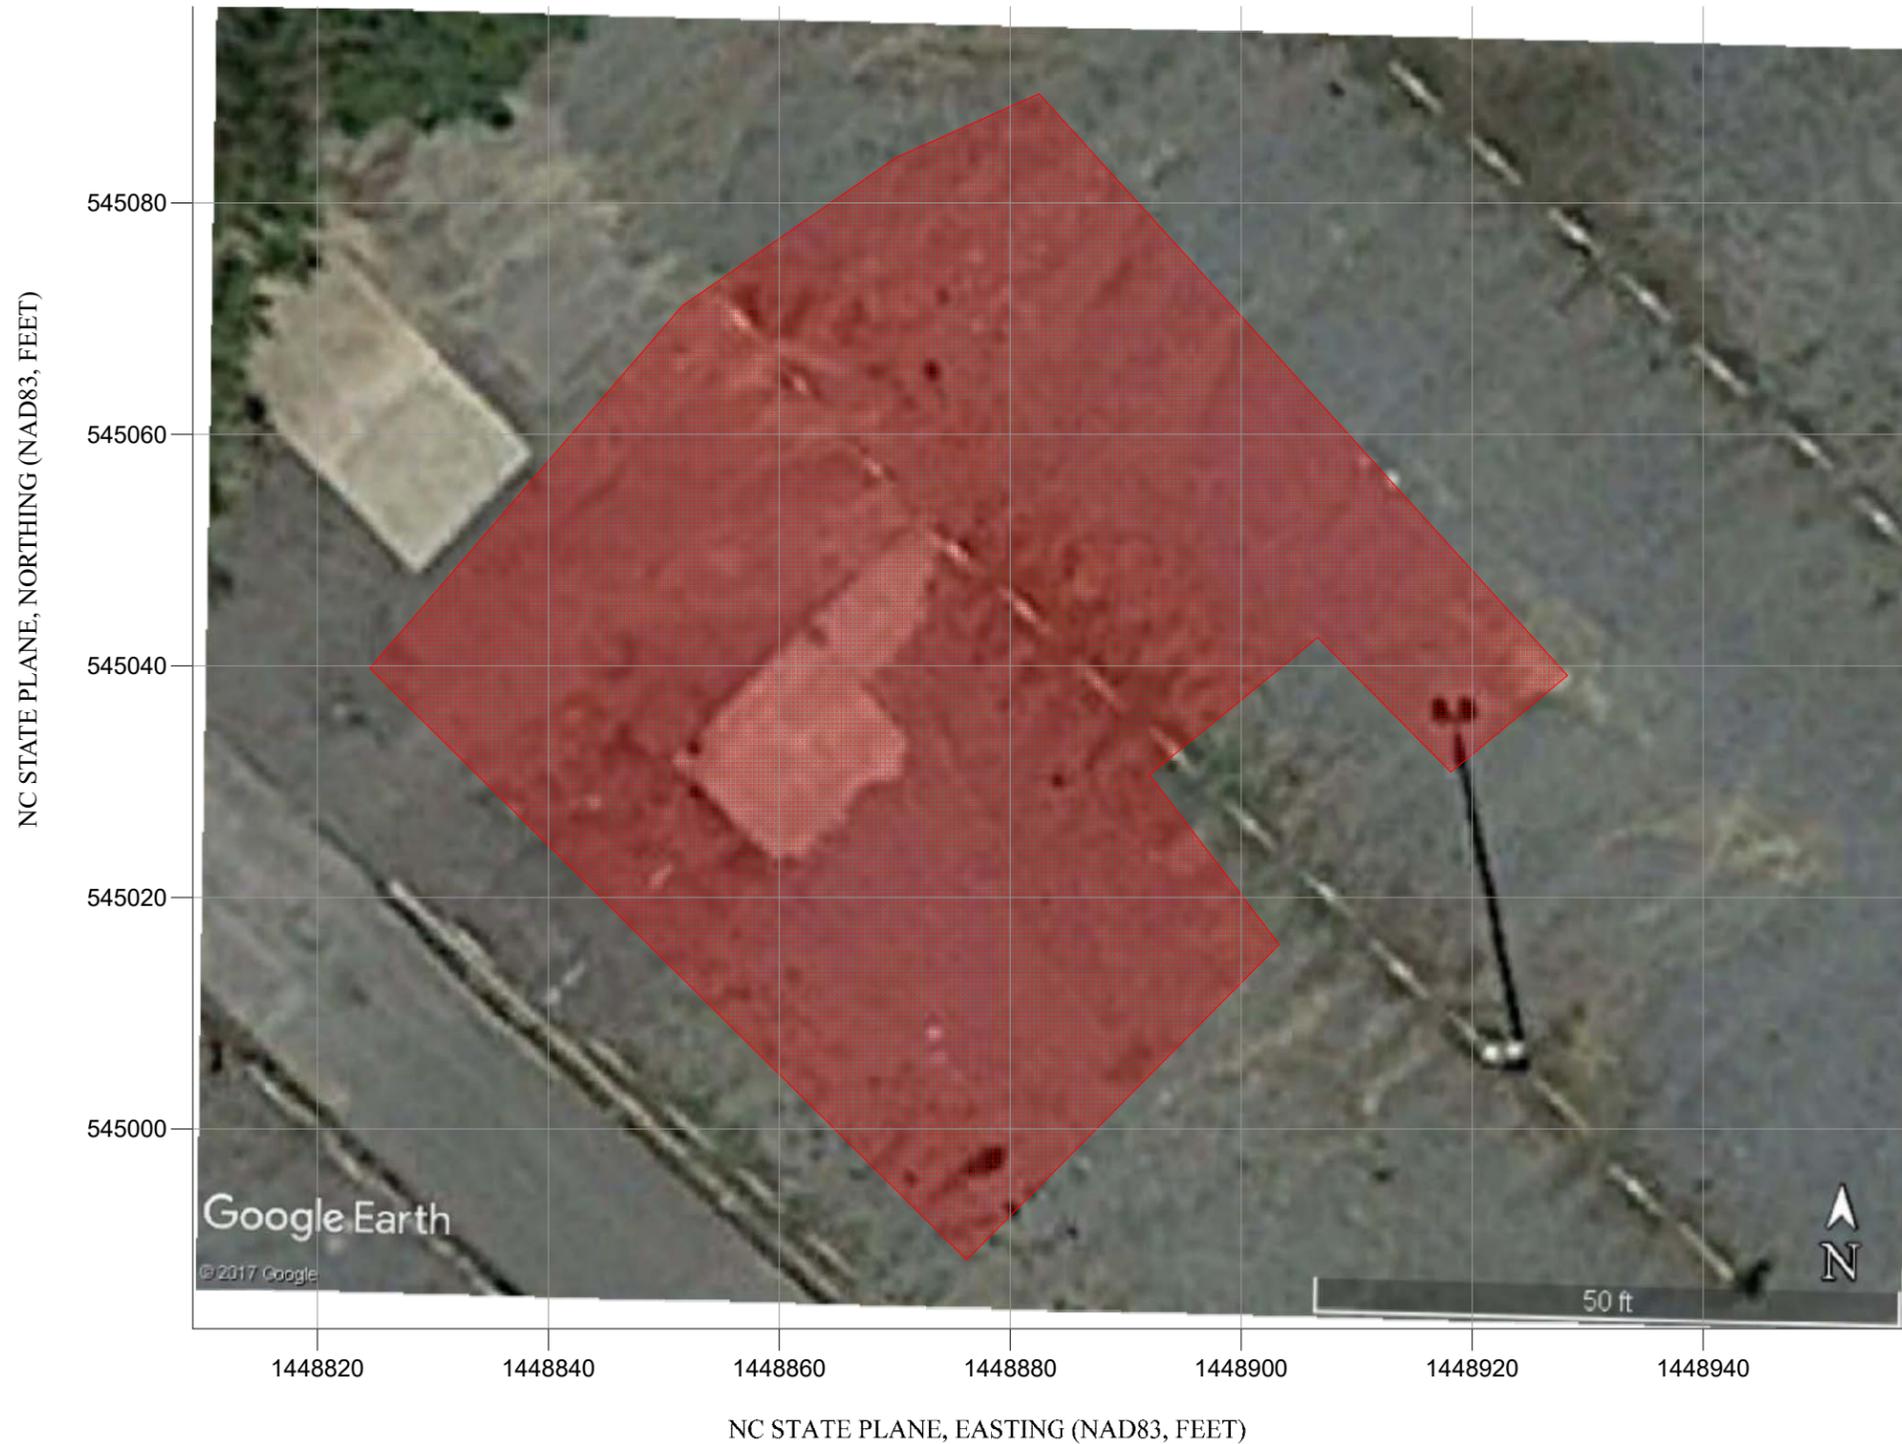
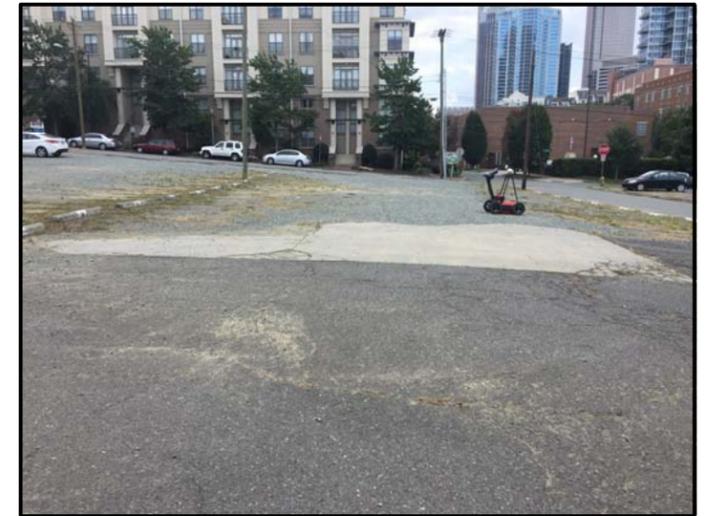
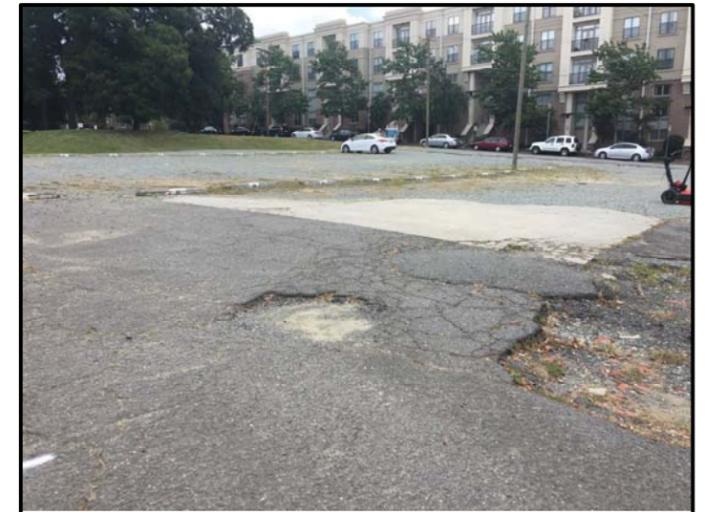
503 INDUSTRIAL AVENUE GREENSBORO, NC 27460 (336) 335-3174 (p) (336) 691-0648 (f) License # C1251 Eng. / License # C257 Geology	
DATE	9/13/2017	CLIENT	NCDOT
PYRAMID PROJECT #:	2017-253	<b>FIGURE 1</b>

The site included an asphalt parking lot with a zone of concrete and several parking barriers. An aerial photograph showing the survey area boundaries and ground-level photographs are shown in **Figure 1**.

View of Survey Area  
(Facing Approximately Southeast)

View of Survey Area  
(Facing Approximately East)

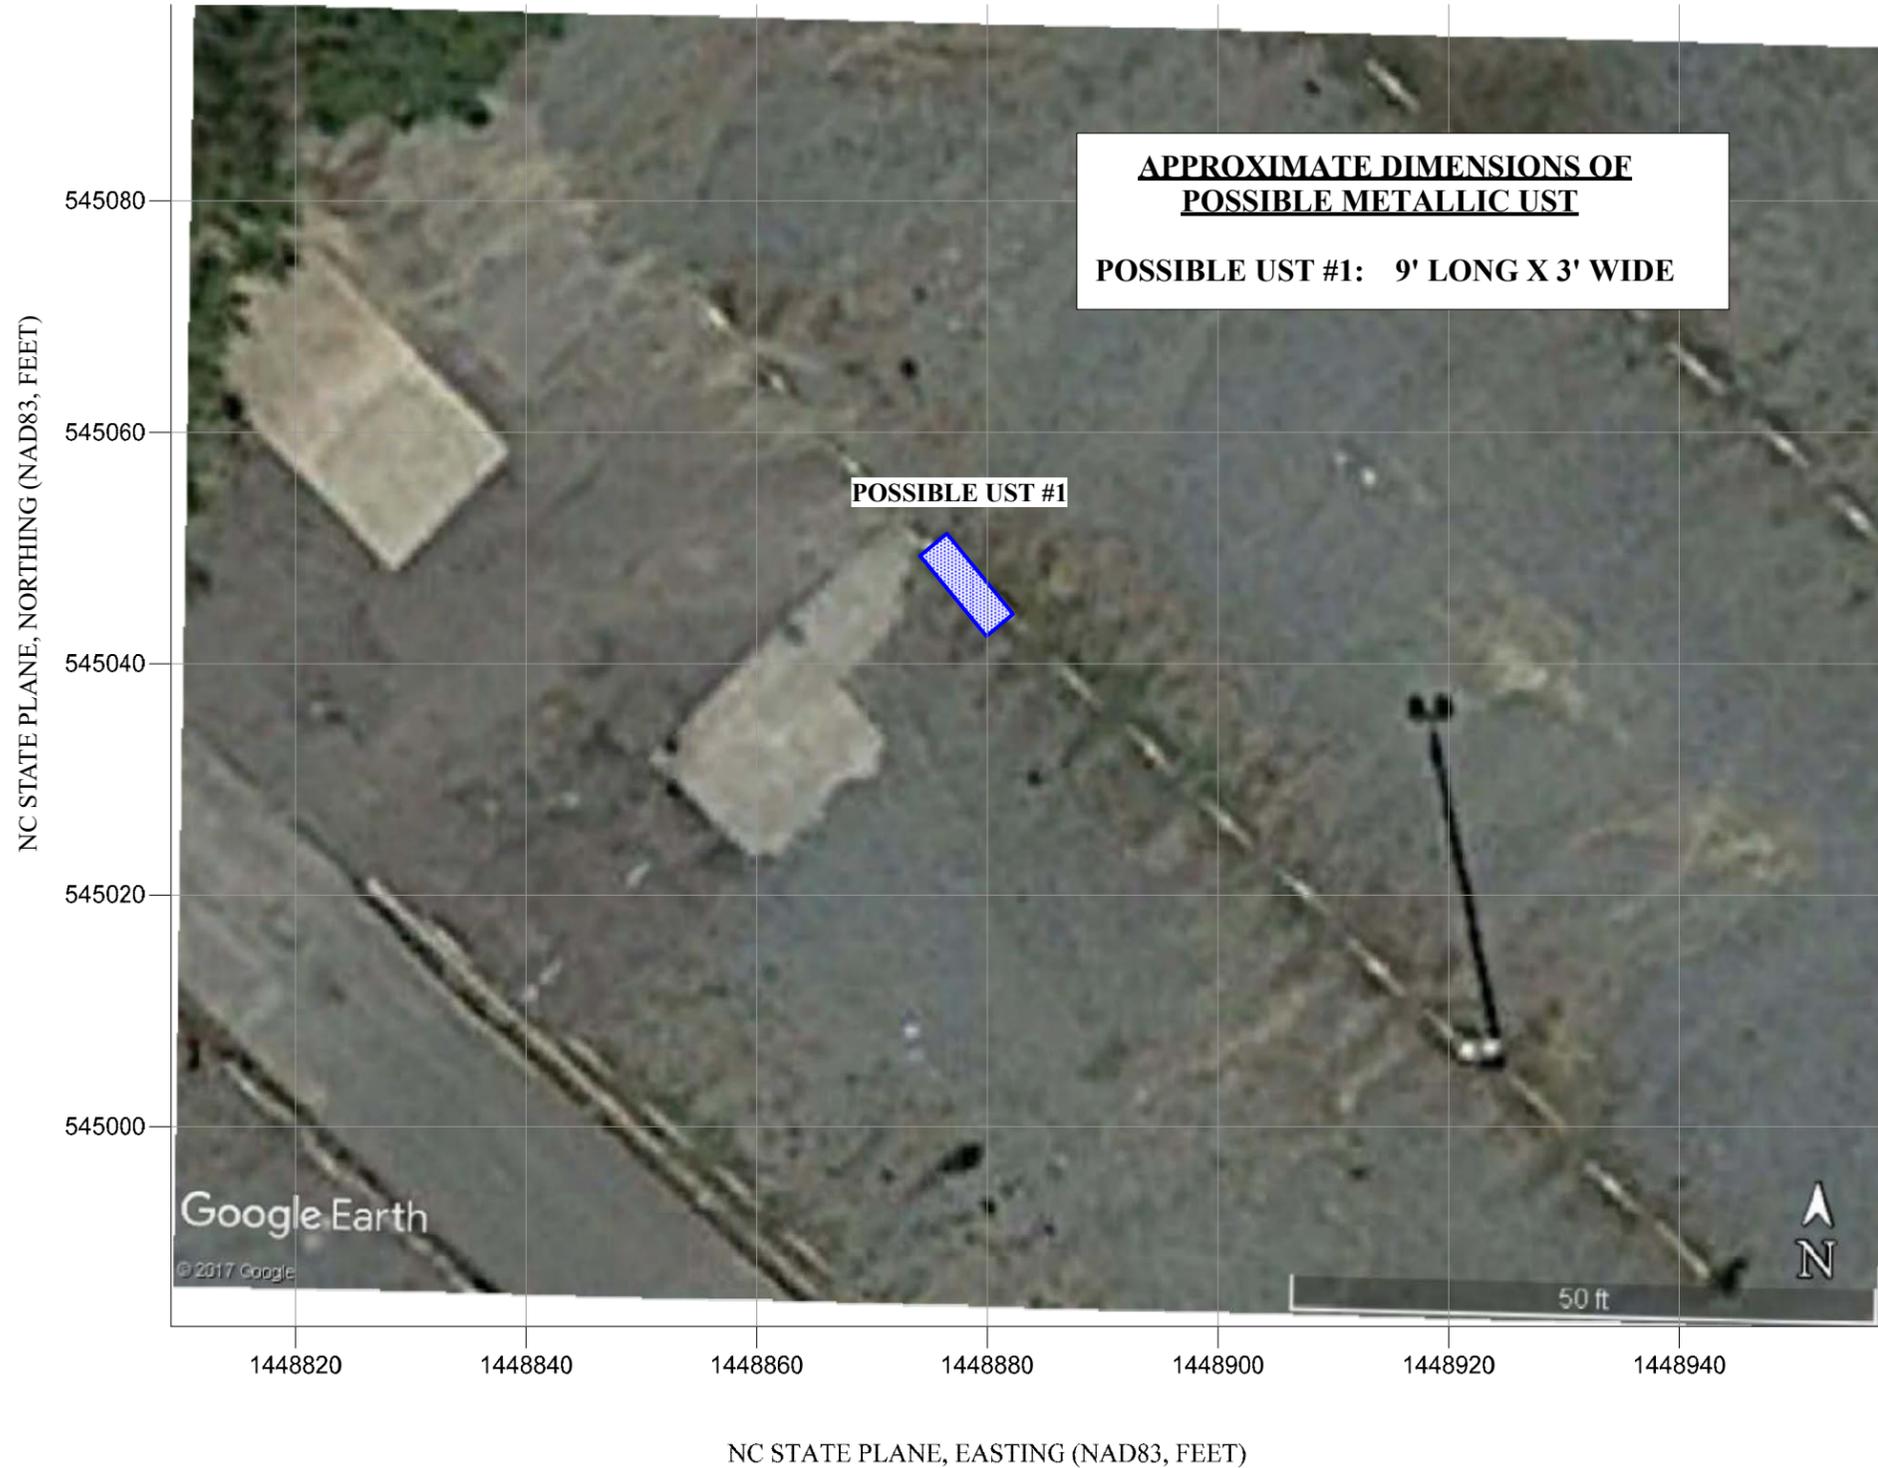
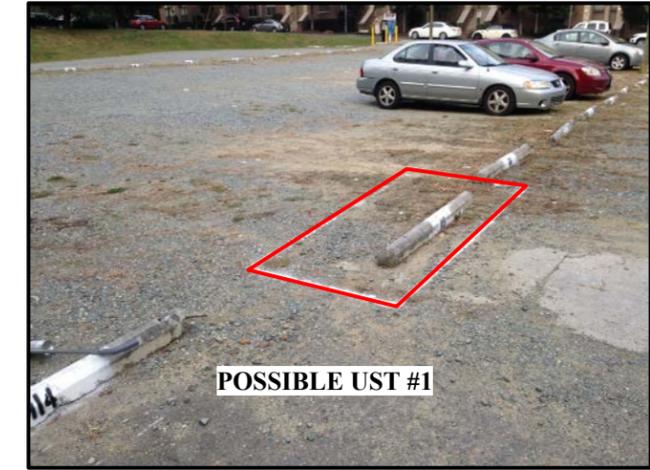
503 INDUSTRIAL AVENUE GREENSBORO, NC 27460 (336) 335-3174 (p) (336) 691-0648 (f) License # C1251 Eng. / License # C257 Geology	
DATE	9/13/2017	CLIENT NCDOT
PYRAMID PROJECT #:	2017-253	<b>FIGURE 4</b>

data result in this feature being classified as one possible UST (center point: 1448878, 545047, North Carolina State Plane NAD83, feet). The possible UST was approximately 9 feet long and 3 feet wide, and was directly below the asphalt surface.

**Figure 4** presents the location of the possible UST on an aerial photograph along with a ground-level photograph.

Collectively, the geophysical data recorded evidence of one possible metallic UST at Parcel 1. The shape of the feature, in conjunction with information from a previous geophysical report, suggests that this structure may be an oil-water separator.

View of Possible UST #1  
Facing Approximately Southeast
